TOWN OF BROME LAKE

Action Plan for a Healthy Lake

2022 2026

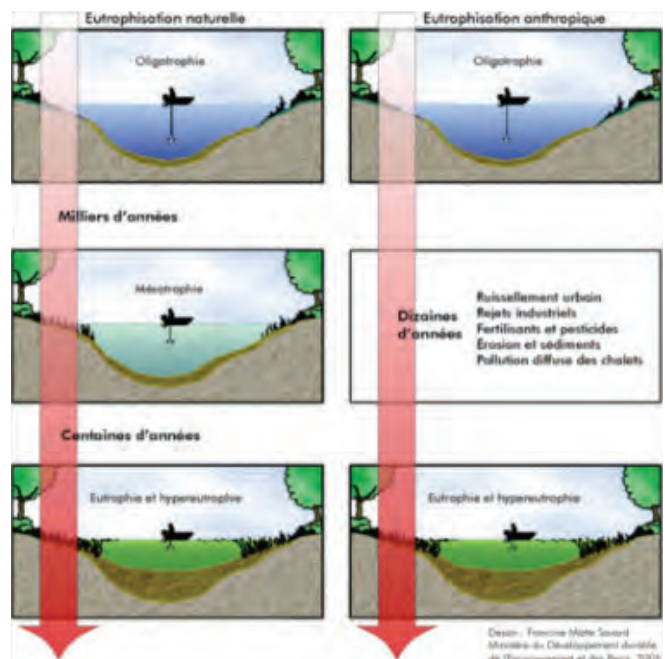
FIGURE 1. Process of Eutrophication Through Natural and Anthropogenic (Human Intervention) Origins

Chemical elements such as phosphorus are essential to plants and algae. On the other hand, too large a quantity can lead to eutrophication of the lake, meaning its transformation into marshland through the accumulation of organic matter. Naturally, this phenomenon occurs over thousands of years but human activities can accelerate this process thus leading to a rapid deterioration of water quality (see **figure 1**). Ultimately, this can threaten the health and sustainability of the lake.

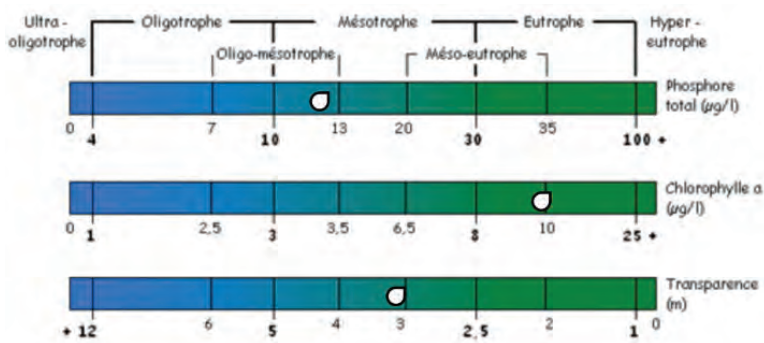
FIGURE 2. Eutrophication Level of Lake Brome

Using the three following indicators, lake Brome has been the subject of analysis to determine its level of eutrophication over the past several years:

1. The total concentration of phosphorus,
2. The level of chlorophyll a and;
3. The water's transparency.

The results allow a diagnosis of the average aging of the lake and prove worrisome (See **Figure 2**). From 2008 to 2021, the average concentration of phosphorus in lake Brome was 12.8µg/l, indicating a mesotrophic state. During the same period, the average chlorophyll level exceeded 10 µg/l, indicating a eutrophic state. This is very worrisome. The average transparency of the water, also from 2008 to 2021, was evaluated at 3 metres in depth, indicating a mesotrophic state. This data was obtained through the average data collected between 2008 and 2021 by the Réseau de surveillance volontaire des lacs (Volunteer Lake Monitoring Network) (environnement.gouv.qc.ca/eau/rsvl/relais/rsvl_details.asp?fiche=278).

The existing amount of phosphorus and the continuing amounts being directed into the lake must be minimized in order to preserve its health. This will limit the proliferation of aquatic plants, algae and cyanobacteria such as blue-green algae, thus resulting in lower levels of chlorophyll and improved water transparency.
